# Delaying Drainage From Prairie Potholes Protects Water Quality

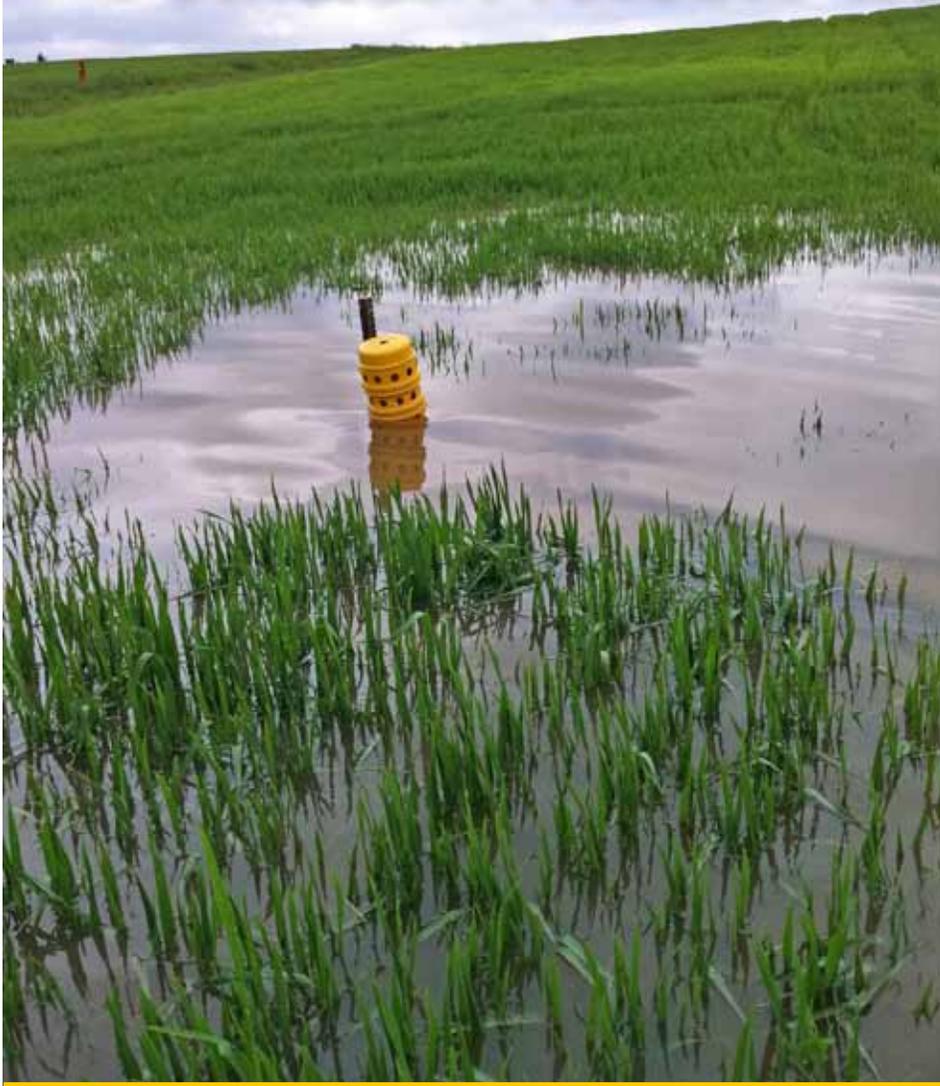
After a storm, a tile riser drains a pothole in a wheat field. Tile risers are perforated pipes extending a foot or more above the soil. Water flows into the holes in the pipe and then typically flows unimpeded and unfiltered into subsurface drains and eventually into streams, causing pollution. An ARS scientist has shown that a blind inlet (opposite page) provides a solution.

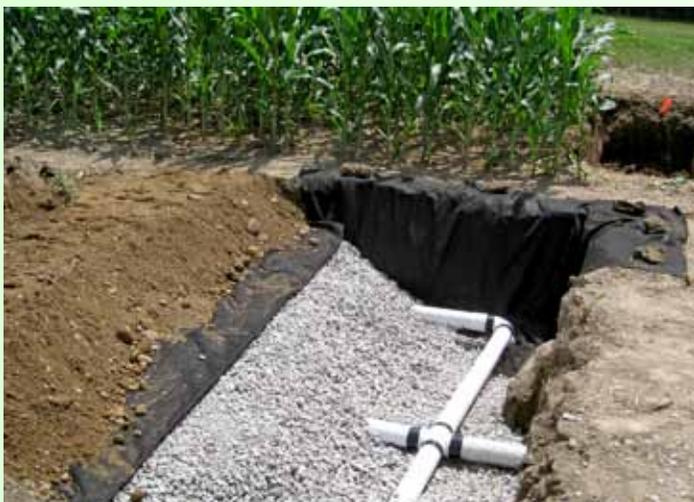
STAN LIVINGSTON (D3005-1)

Construction of a blind inlet. Septic tiles are placed on top of a layer of coarse limestone gravel, covered in a second layer of gravel, encased in landscape fabric, and backfilled with coarse soil to facilitate infiltration.

A blind inlet is similar to a French drain that channels excess water away from a building foundation. The scientists constructed their blind inlets by digging a square pit 3 feet deep at the lowest point of the pothole and then placing a layer of coarse limestone gravel in the bottom of the

pit. Septic tile lines were placed on top of the gravel layer and covered with another layer of limestone gravel. The second layer of gravel was covered by landscape fabric, and the rest of the hole was backfilled with coarse soil to facilitate infiltration.

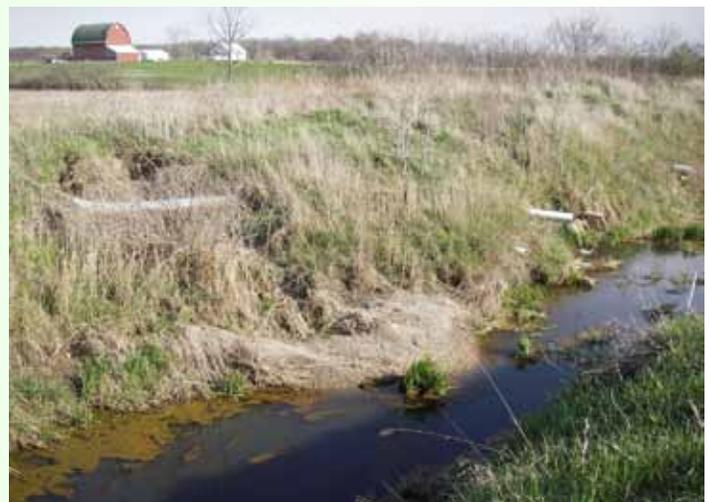
DOUG SMITH (D2768-1)

Water drained from potholes by tile risers is discharged via subsurface drains into the nearest field ditch without any filtering to remove excess phosphorus, nitrogen, or sediment.

The tile risers are also a key component of a serious long-term—and widespread—environmental issue. Water drained from potholes by the risers is discharged via the subsurface drains into the nearest field ditch without any filtration or processing to remove excess phosphorus, nitrogen, or sediment. In these landscapes, Smith says, field ditches function as first-order streams.
